CENTRAL INTELLIGENCE AGENCY

| SUBJECT | 1. Maintenance Work on MiG-17's at Jueterbog Airfield 2. Technical Information on the MiG-17 | DATE DISTR. | 28 February 1957 | |

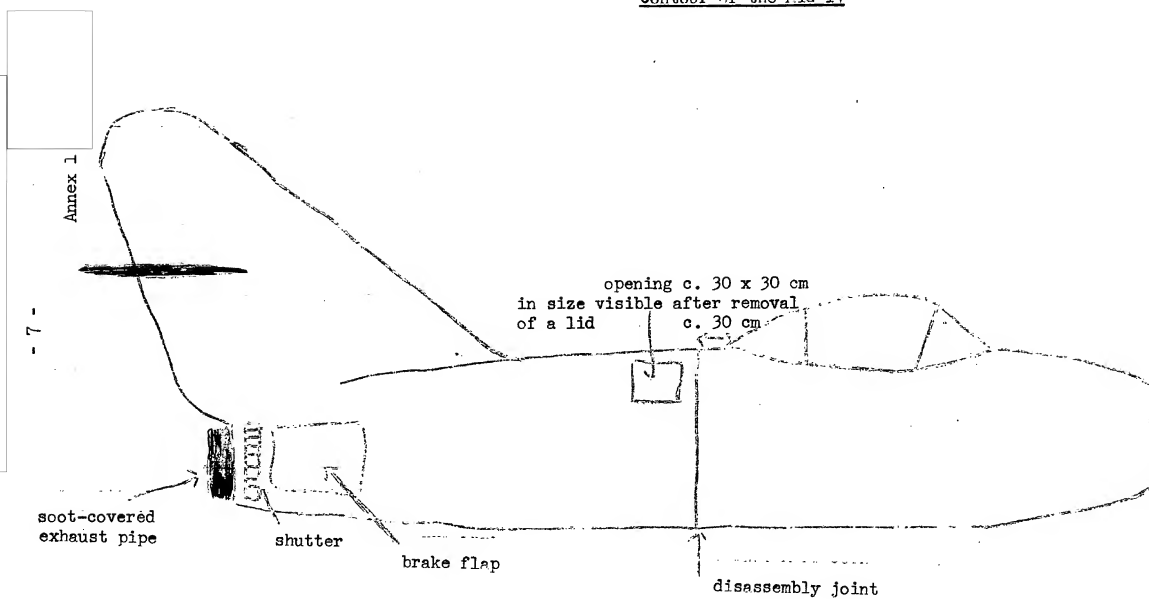
Sketch 1:

1. All engines were dismounted, provided they had not been exchanged for some reason shortly beforehand. Two or three engines at the most could daily be removed from MiG-17s. Work on one aircraft had to be completed before the beginning of work on the next aircraft. Two to 2½ hours were required to remove the engines and all work was done slowly and with great exactitude by two officers giving directions to 6 or 7 men. Some of the personnel were sitting on the aircraft, while others were busy opening flaps under the fuselage. Especially noted was a 30 x 30-cm opening on the starboard side on the upper side of the fuselage, directly behind the disassembly joint of the removable portion of the rear fuselage covering. The edges of the opening were slightly rounded. The disassembly joint of the covering was located about 30 cm behind the cockpit.¹

Contour of the MiG-17

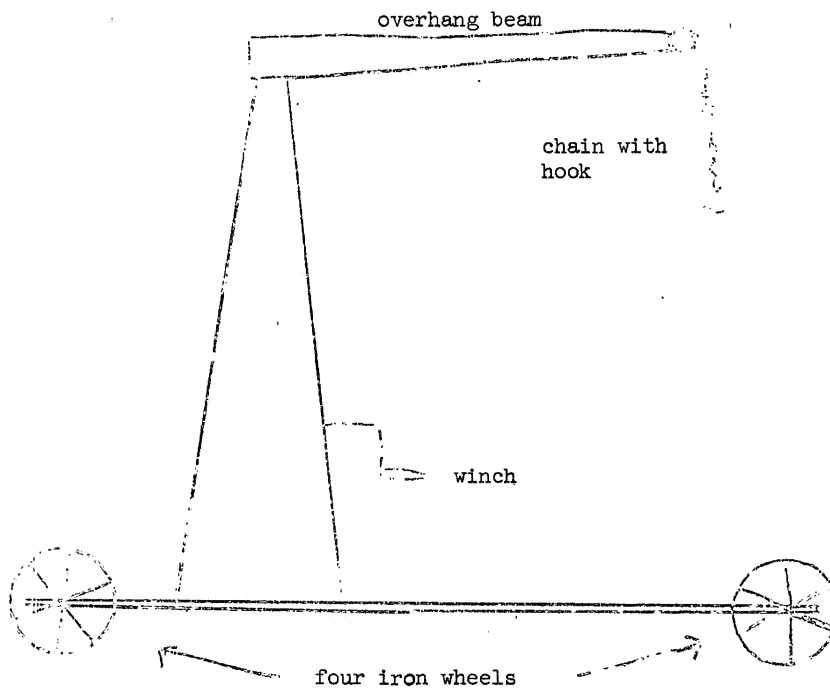
Sketch 2:

- 1 crane truck on 4 small iron wheels. A chain with a hook suspended at the overhang beam of the crane and catching an eye on the engine was operated by means of a winch.²
- 1 cart with 2 supports fitted to the lower fuselage and padded with leather.³
- 2 jacks, each placed under one of the wings.⁴

Approximate appearance of crane truck

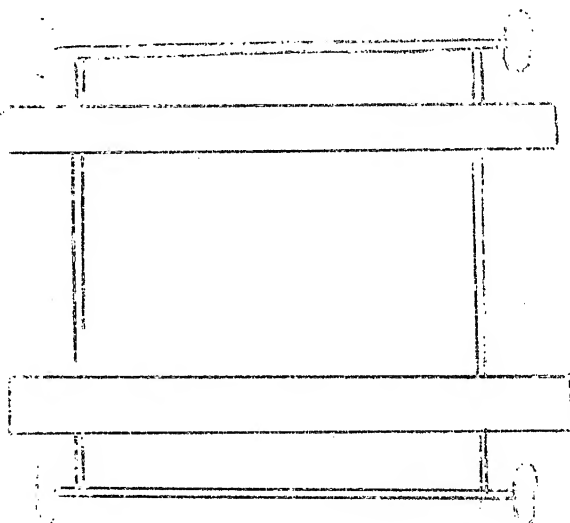
Sketch 4: as seen
from above

Cart to transport rear portion of fuselage
(approximate appearance)

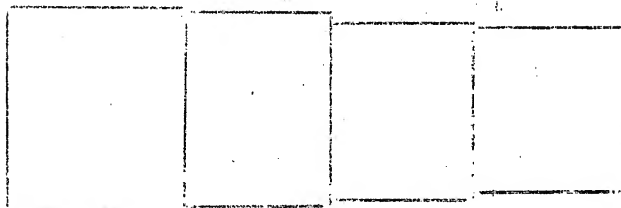
Sketch 8: side view of removable exhaust pipe.

Length at least 2 meters, tapering off toward the end.

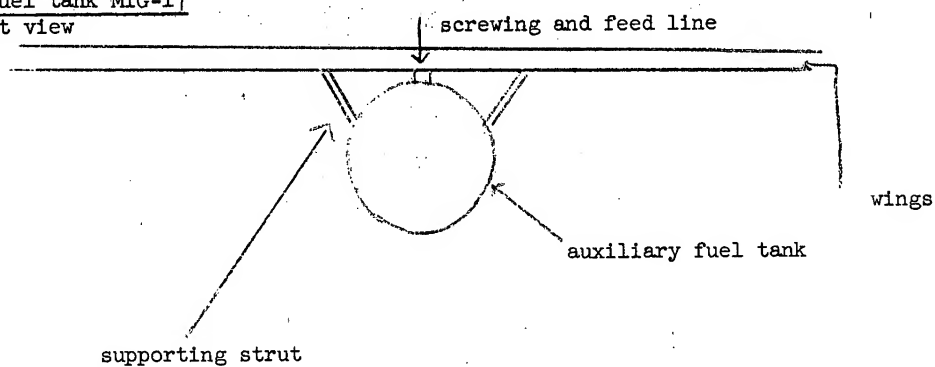
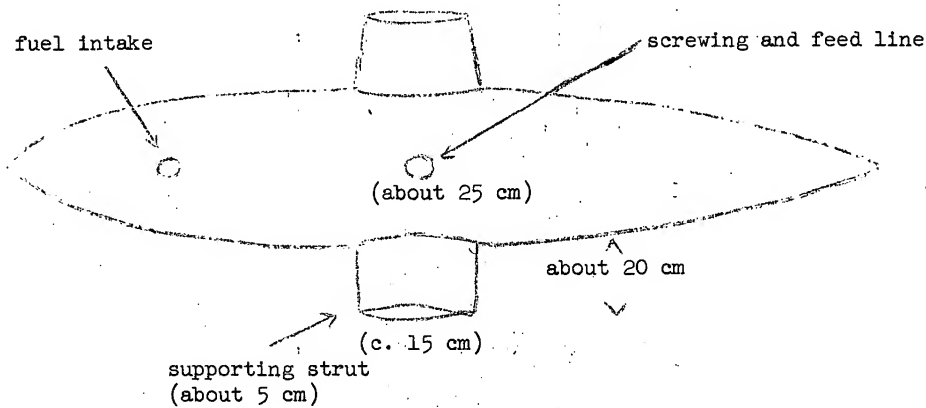
Auxiliary fuel tank MiG-17
Sketch 10: front view

- h. The auxiliary tanks were supported by 2 struts, the ends of which pressed against the lower side of the wings or were gripping especially provided notches or slits in order to prevent the slipping or shaking of the auxiliary fuel tanks. A screwed joint as reinforcement and fuel pipe was attached in the middle of the tanks. An opening for refueling was located in the upper side in front of the fuel tanks.¹²

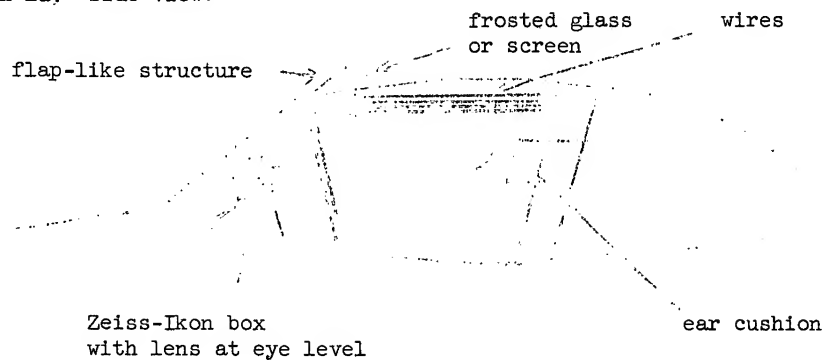
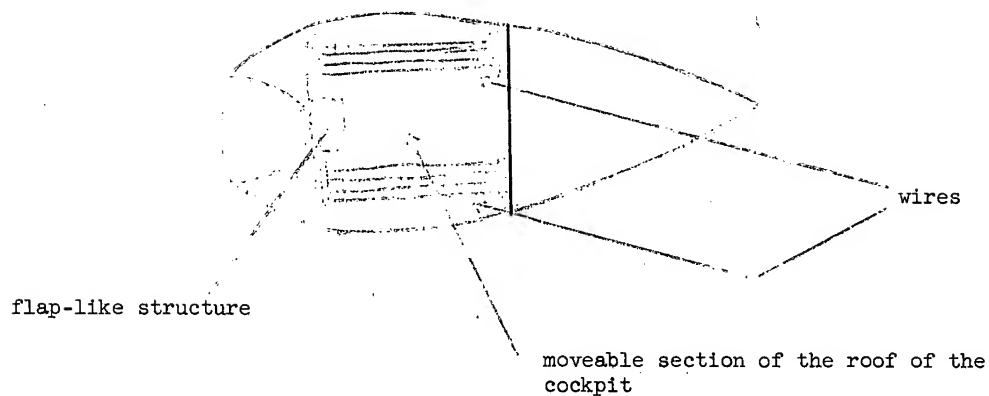
Cockpit MiG-17

- c. A box with a "lens" of about 5-cm diameter was placed on the black box ("socket") directly level with the face of the pilot and thus hindering his sight toward the front. The "lens" faced the pilot. The box had a height of about 20 cm, a width of about 15 cm and was about 15 cm deep. A commercial sign, Zeiss Ikon, could be seen on the port side of the box. The box with the lens could only be observed in MiG-17s and not in two-seater aircraft. An approximately 8 x 8-cm rear-view mirror, presumably for the second pilot, was located at the right front side of the front pilot in two-seater aircraft.⁹

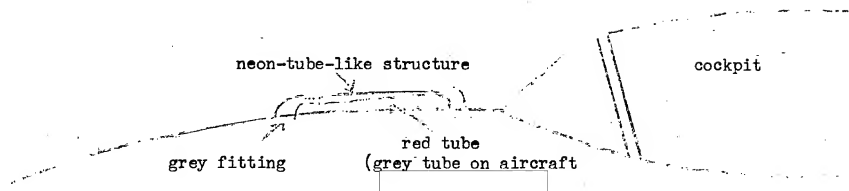
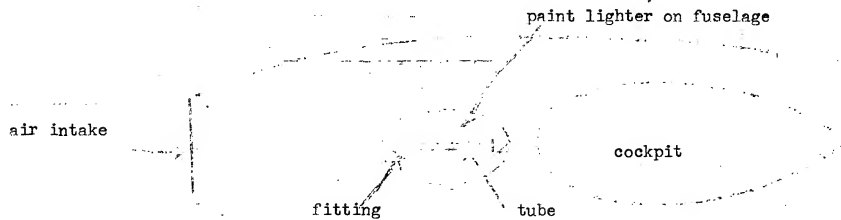
Neon-tube-type structure
at the upper side of the MiG-17 fuselage

- e. A sort of neon tube was located on the upper side of the fuselage in front of the cockpit. These tubes were observed on all aircraft in hangar No. 4; it could not be determined, however, whether or not aircraft in other hangars had the same tubes. Two-seater aircraft did not have this tube. Prior to the "exchange" of aircraft [redacted] these tubes at the front upper side of the fuselage did not exist, and it is possible that they were installed during the temporary absence of the MiG-17s as the tubes could be observed after the return of the aircraft. The tubes had a length of about 40 cm, a diameter of about 5 cm and were painted red or grey. The surface of the fuselage on which the tube was mounted had lighter paint than the rest of the fuselage. Aircraft [redacted] was the only aircraft to have a grey tube.¹¹ 25X1
25X1

11. See Annex 8, sketch 15 and 16. This tube-like structure has been reported elsewhere as having been seen at the lifted front section of the fuselage and it had incorrectly been assumed that the tube was located under the flap. The structural outside had been compared with frosted glass and a cable extending under the tube had been mentioned. The structure can be recognized on the photographs of MiG-17s
